**PRELIMINARY ASSESSMENT/  
VISUAL SITE INSPECTION**

**LECO CORPORATION  
FORMERLY HAYES ALBION PARAMOUNT DIE CAST  
STEVENSVILLE, MICHIGAN**

**MID 005 135 785  
FINAL REPORT**

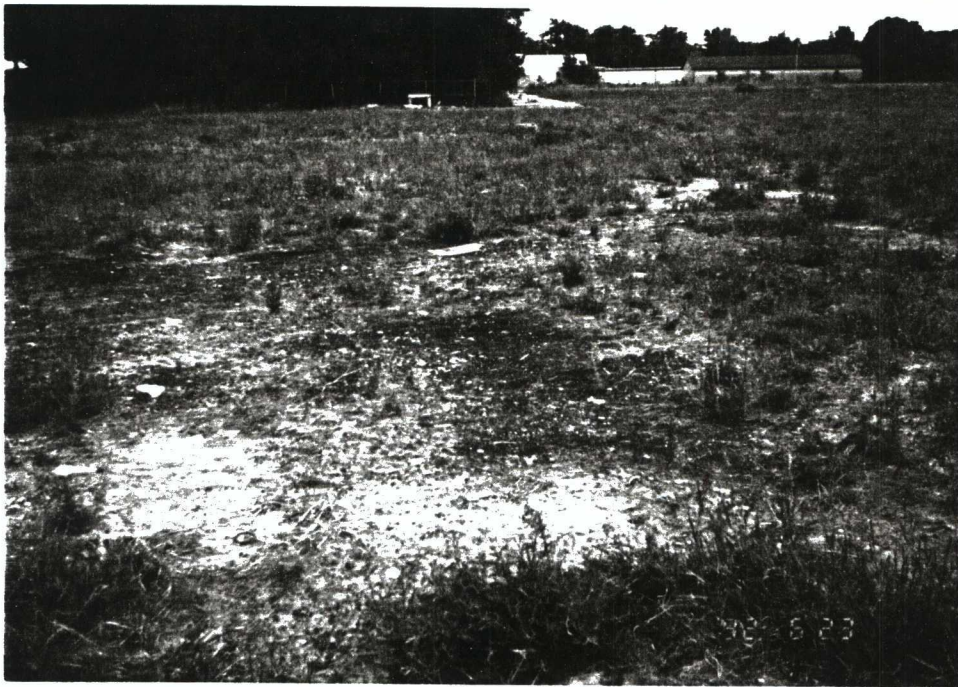
Location: SWMU 1  
 Date: June 23, 1992

**Observations:** PRC observed that the unit has been removed from the facility. PRC did not observe any evidence of release in the area.

Photograph No. 1  
 Orientation: West  
 Description: Approximate location of Former Drum Storage Area

PRC recommends EPA resolve the regulatory status of this unit as closed or initiate RCRA closure of the unit, as necessary.

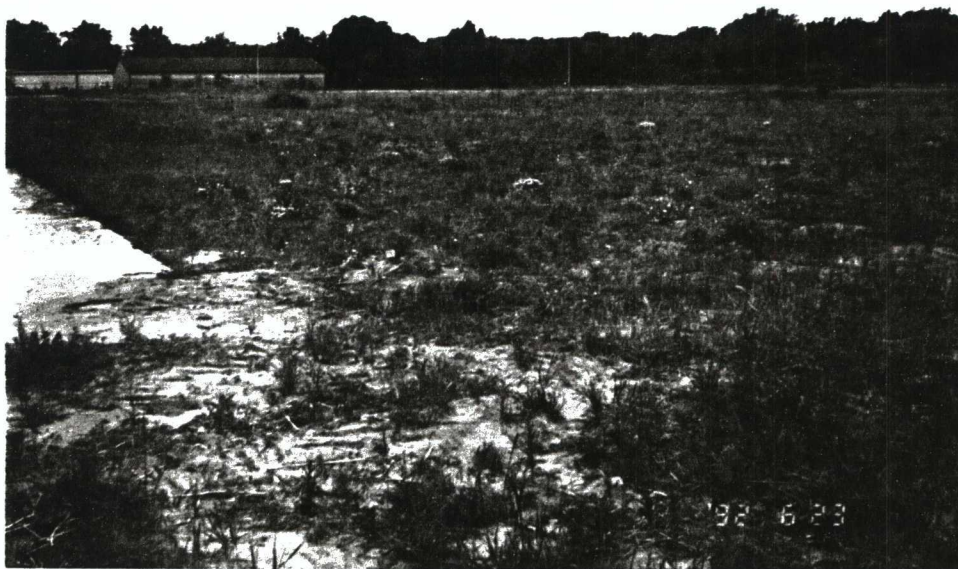
Location: SWMU 2  
 Date: June 23, 1992

**History of Documented Releases:** In 1982 and 1986, this unit has had documented releases of wastewater and excess hydraulic oil. The 1982 release included oils contaminated with PCB. The 1986 release was caused by a break in old process piping.

**Observations:** PRC observed that there was no indication of the unit. At the time of the VSI, PRC did not observe any evidence of release in the area.

Photograph No. 2  
 Orientation: South  
 Description: Approximate location of Former Tile Field and remediation activities

Recommendations: PRC recommends no further action for this SWMU at this time.
